Re: Request for extension of Final Delivery Date
Lucero Apartments (f/k/a Oak Creek Village) Austin, Texas
Fannie Mae Forward Commitment No.: 874426
PNC Loan No: 310401235

At your request, Wiss, Janney, Elstner Associates, Inc. (WJE) has performed additional assessment of the stucco installation at the Oak Creek Village Apartments buildings, located at 2324 Wilson Street in Austin, Texas. The additional assessment included review of additional information not available to us prior to issuance of our July 22, 2016 report. This letter amends and supplements our previously provided findings and presents recommendations.

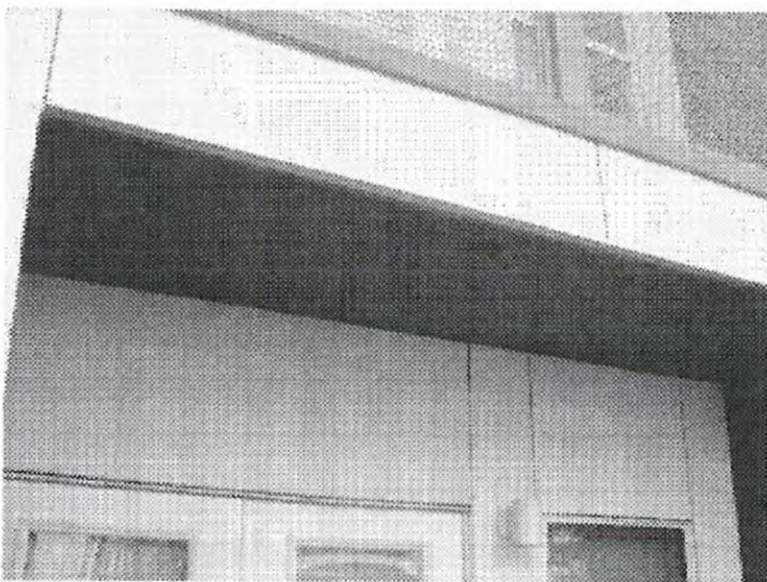
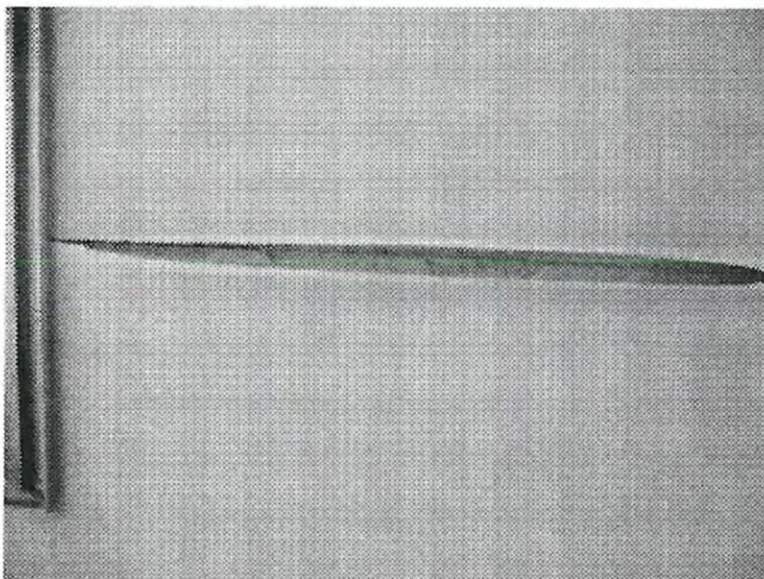
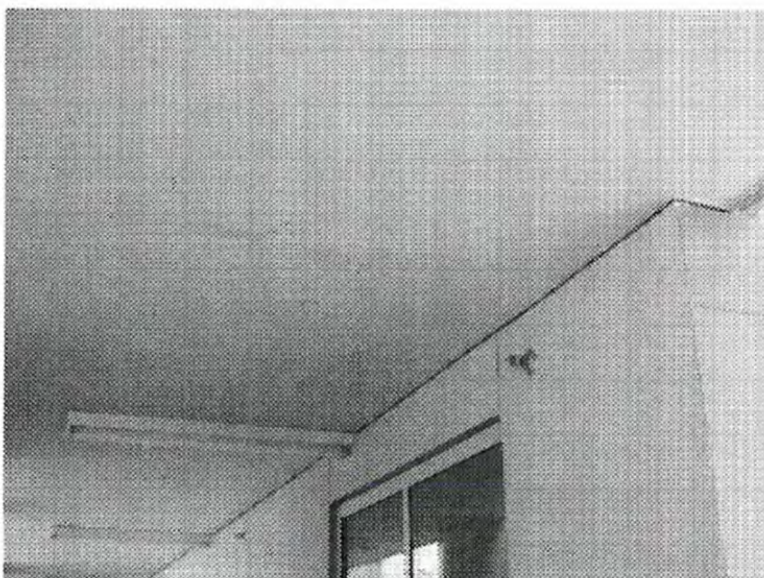
We understand from Weis's response letter that they were told to proceed with mudding the soffit joints, despite warning that the sort of separation observed would occur. In at least two instances, we also observed water damage at these joints. Possible sources of the moisture could include condensation within the soffit, leakage from exterior walkways above, or plumbing leakage. Additional investigation, including openings in the soffits at these stained locations, would be required to determine the cause and develop repair recommendations. This additional investigation is beyond the scope of our assessment.

Figure 42. Separation at soffit board joint on Building 4.

Figure 43. Separation at soffit board joint.

Figure 44. Soffit board joint showing apparent water damage.

As the observed distress is already occurring at many of the joints, it will likely spread to most, if not all, of the panel joints. We recommend refinishing the joints and allowing them to ventilate the plenum space above. Where water damage has occurred, we recommend removing and replacing the affected panels.

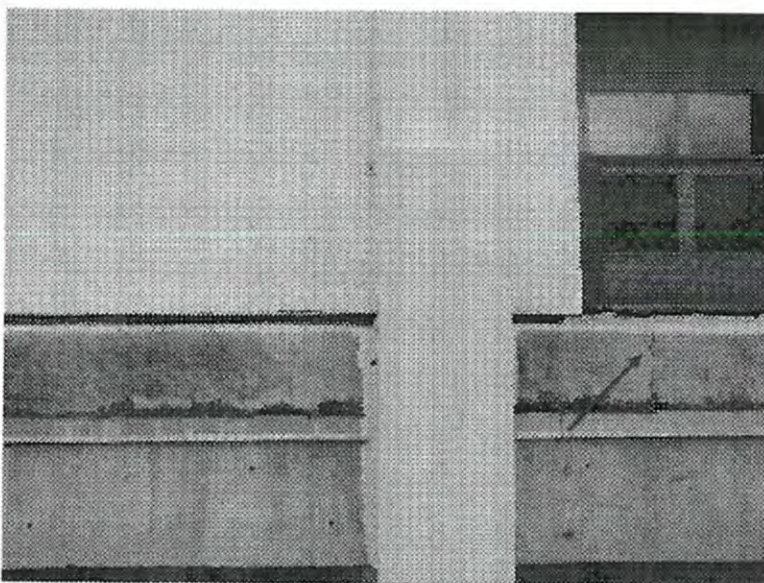
Despite the indications on the architectural and structural drawings, we did not observe any expansion joints in the as-constructed conditions between buildings or within cladding materials. We did observe an increase in the frequency of separations at the soffit panel joints near breezeway connections between buildings. The differential movement of separate buildings may explain distress at soffit panels as well as the stucco at nearby column heads, promoting separation.

Currently, evidence of differential movement between buildings was observed at the podium concrete, in cracks at the stucco, and at separations of soffit panel joints near the adjoining breezeways; however, continued damage may occur over time if this condition is not addressed. We recommend providing the expansion joints in the exterior finishes at locations indicated in the construction drawings as well as an additional set between the two segments of Building C.

Figure 45. Crack between Buildings A and B at west elevation; note lack of building expansion joint in this location.

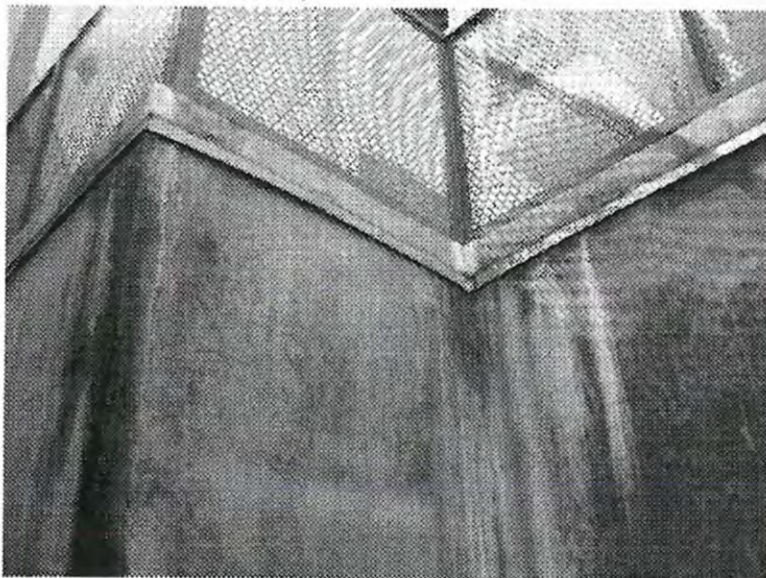
We observed a significant amount of efflorescence stemming from the split-slab waterproofing system at the podium, along with some staining from the railing above. This efflorescence appears to be a result of water migrating through the finished surface over the podium, where it contacts the waterproofing surface and drains to the exterior, between the structural and topping slabs. This is primarily an aesthetic concern. Efflorescence can be cleaned from the surface of concrete masonry cleaning solutions but will reappear with additional water migration. It may lessen gradually over time as the amount of water-soluble mineral salts within the concrete is reduced. The corrosion from the railing above, however, can lead to premature failure of the systems, and, indeed, a spall appears to have formed at one corner of the concrete supporting the railing. Refer to the recommendation above regarding the railing. Concrete spalls can be removed and patched.

Figure 46. Efflorescence visible with active wetting at split-slab condition of podium.

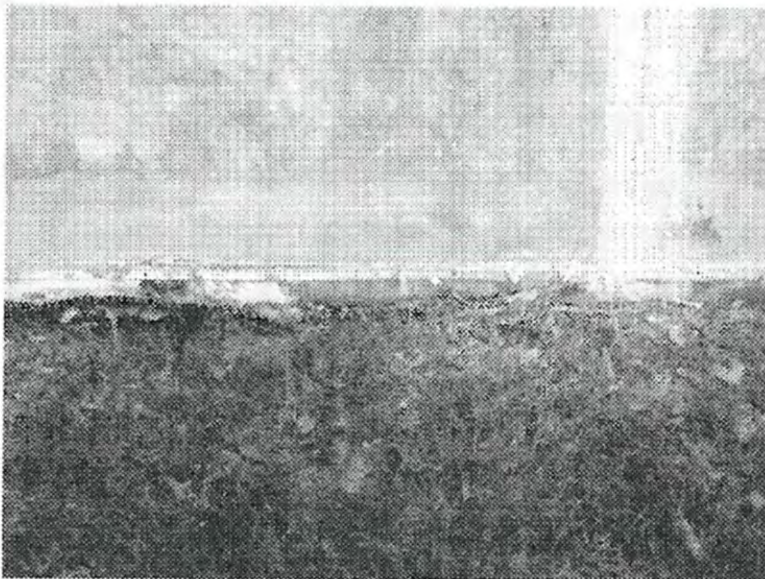
We also observed damage to the below-grade waterproofing termination in one location at the base of the podium. This damage appears to be related to settlement of the adjacent soil, which can apply pressure on

Figure 47. Damage to below-grade waterproofing termination visible at base of podium and lack of protection of top of waterproofing.

the membrane and cause disengagement from the substrate. WJE recommends excavation of a small area of soil adjacent to the damaged below-grade waterproofing to allow for repair of the existing membrane. A new termination bar should be installed at the top edge of the membrane to protect against further movement of the membrane due to soil settlement. The top of the waterproofing should be also protected from UV.

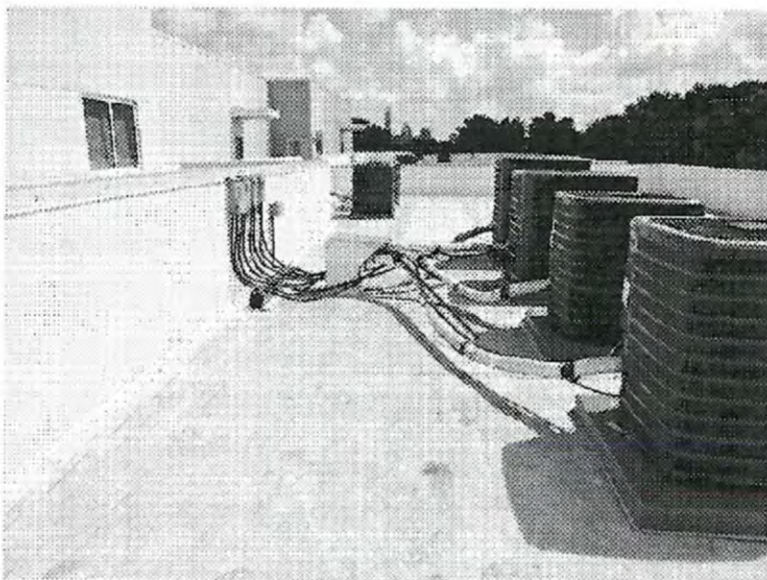
At the roof level, we observed several conduit hoods with spray polyurethane foam (SPF) used to provide an air seal around the conduit. Because SPF is not UV stable, it will deteriorate quickly, resulting in discontinuity in the air and moisture barrier. This could potentially lead to condensation or water infiltration to the building interior. We recommend cutting back the exposed SPF and covering the opening with a metal panel notched around the conduit and then sealed at the perimeter and conduit interfaces.

Figure 48. Spray foam used to seal conduit hoods on roof.

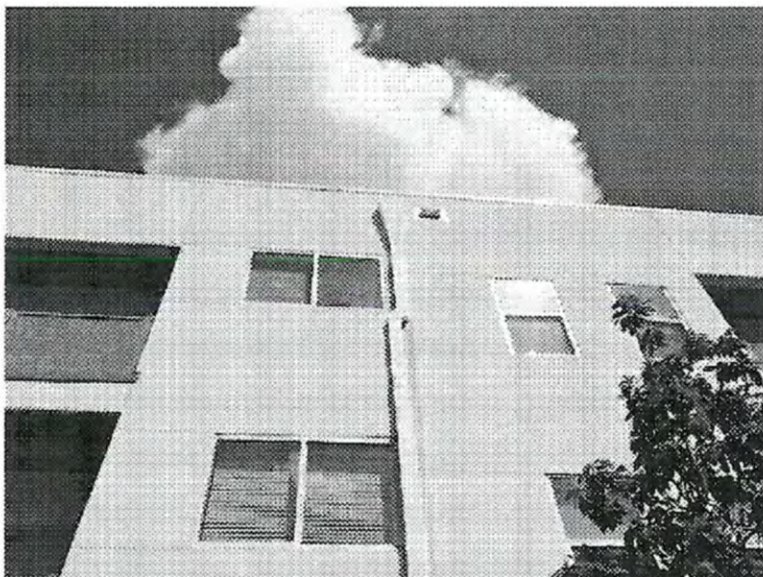
Figure 49. Staining resulting from leak in downspout connection.

In a couple of locations, leaking downspout connections resulted in staining of the stucco finish. These connections can be corrected with sealant between sheet metal sections, and discolored stucco can be cleaned as noted above.

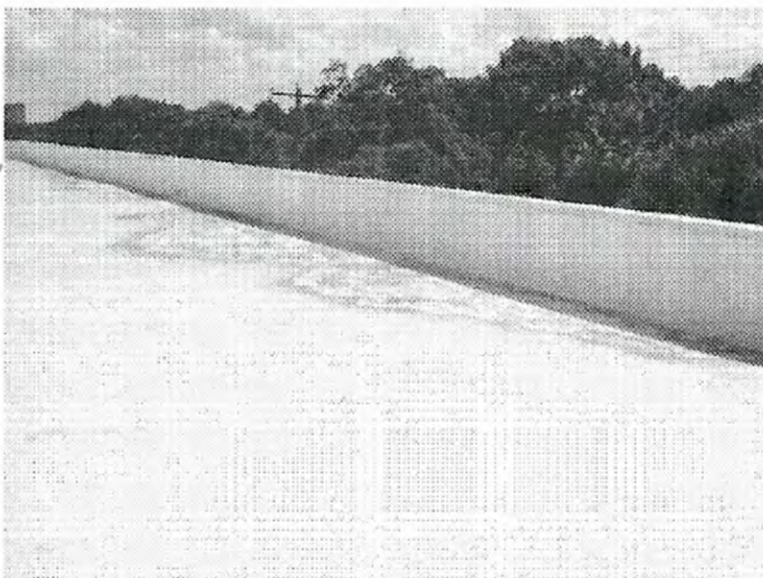
One sizeable area of ponding water on the roof was noted on the east side of Building C. We understand from Weis's response letter that the roofing manufacturer has provided a warranty. While many roofing warranties exclude ponding, this one does not. Therefore, even though the ponding can lead to premature deterioration of the roof membrane, we expect the warranty to cover this issue for the expected life of the roof system.

Figure 50. Large area of apparent ponding water on eastern portion of roof over Building C.

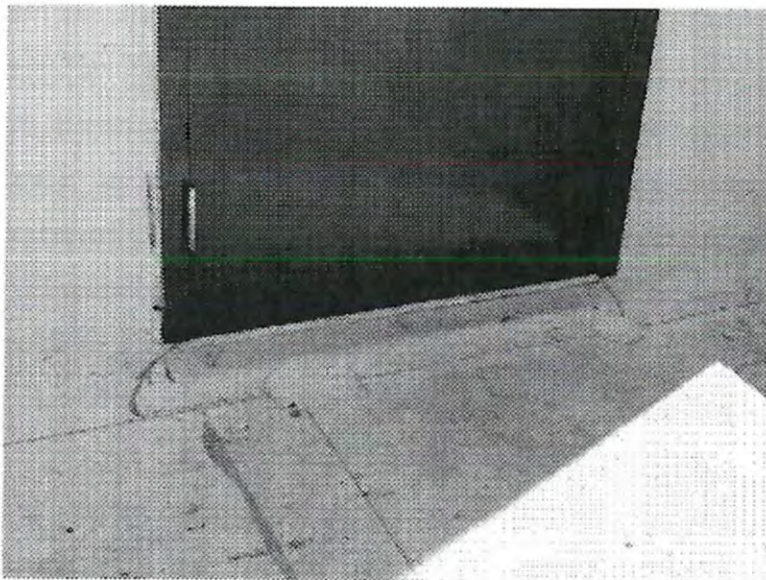
Figure 51. Roof access door threshold lower than industry standard 8-inch minimum.
